HOUSATONIC RIVER BASIN

WATERBURY, CONNECTICUT

EAST MOUNTAIN RESERVOIR DAM CT 00032

PHASE I INSPECTION REPORT NATIONAL DAM INSPECTION PROGRAM

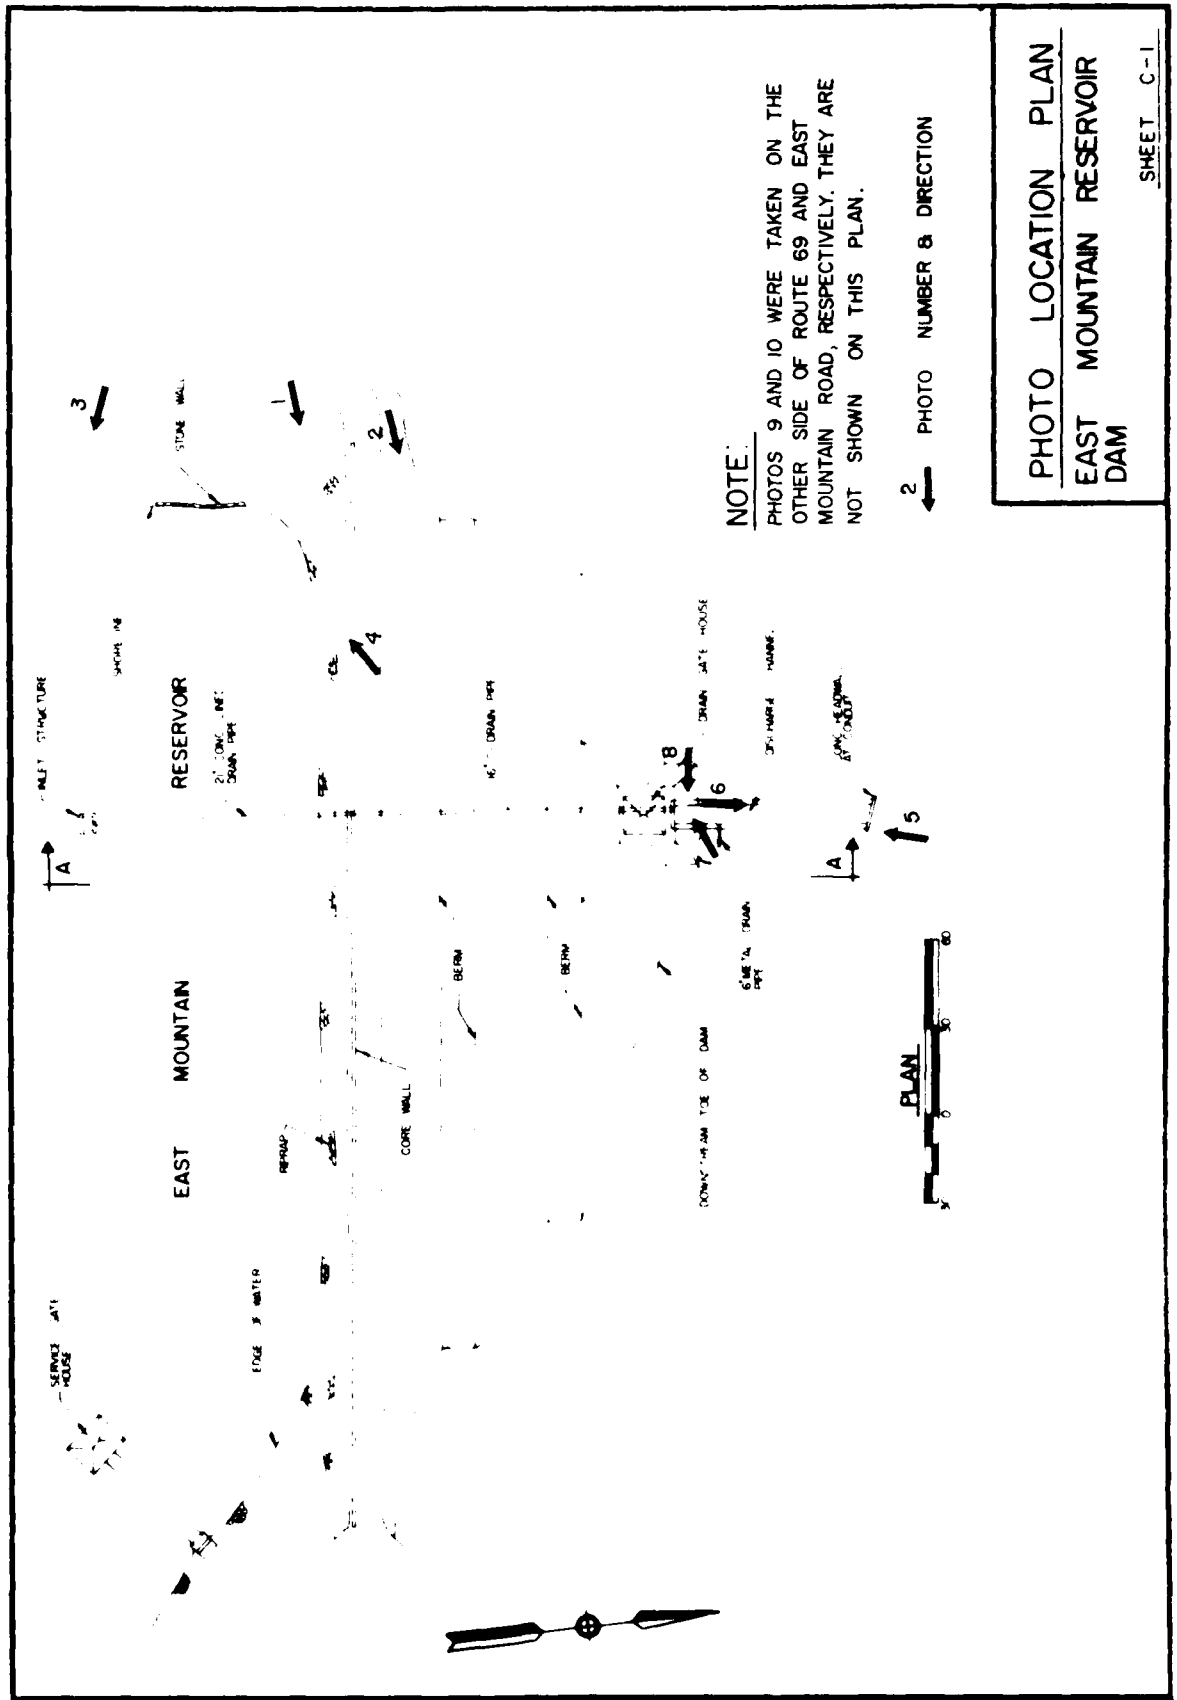
Crest - The crest appears to be in good condition (Photo 1). No cracks, erosion or depressions were observed on the crest.

Upstream Slope - The dumped riprap on the upstream slope appeared to be in good condition (Photo 1) except for the left side of the dam where there is a visible erosion zone with no riprap (Photo 4). The stone wall along the left shore is in poor condition with several areas deteriorating and stones falling into the reservoir.

c. Appurtenant Structures - The abandoned service gate house located at the right upstream side of the dam (Photo 1) is in good condition. Some spalling of the concrete on the northern corner of the gate house was observed. An examination of the inside of the concrete chamber did not reveal any leaks through the concrete walls.

Photo 1 - Crest and upstream slope from left abutment
